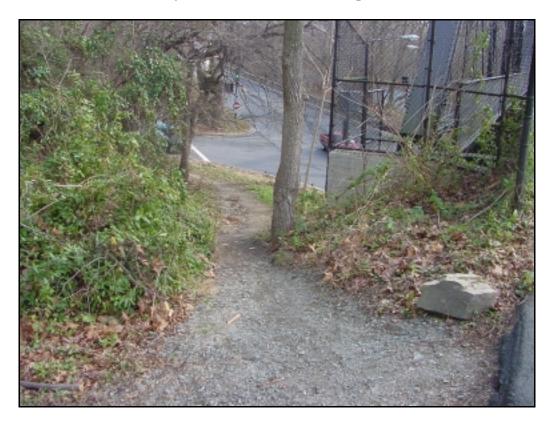
Figure 29
Pedestrian Path from Arizona Avenue to Capital Crescent Trail

• Pedestrian access to Capital Crescent Trail

- 1. The new sidewalk would be relatively low-cost. Part of the necessary improvements already exists on Arizona Avenue. The new pedestrian facility would allow pedestrians/bicyclists to walk down to the intersection of Canal and Arizona and access the Capital Crescent Trail. Pedestrians are currently crossing this intersection with no crosswalk and no pedestrian signal heads. The proposed improvements would increase pedestrian safety at this intersection.
- 2. The ramp would provide a means for trail users to reach the trail via Potomac Avenue. A more detailed study would be necessary to determine the feasibility and cost-effectiveness of this option.

1. Construct sidewalk on east side of Arizona Avenue from Sherrier Place to Canal Road. Add a crosswalk across Arizona Avenue at Canal Road and pave the pedestrian path from this intersection to the Capital Crescent Trail (Figure 29). Install pedestrian signal heads.

• Implement preliminary improvement 1.

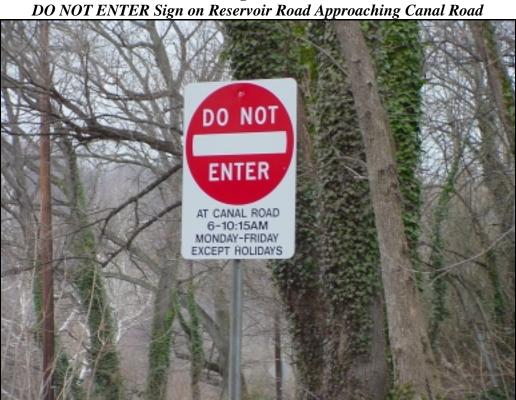
Figure 30 OO NOT ENTER Sign on Reservoir Road Approaching Canal Road

• Inadequate wording on the "DO NOT ENTER" sign at top of hill going towards Canal Road (Figure 30).

- 1. The current wording of this sign implies that the do not enter is at Canal Road. However, for drivers who misinterpret the sign, there is nowhere for them to turn around before reaching Canal Road. Removing "at Canal Road" from the sign removes ambiguity.
- 2. Relocating the sign to the last driveway/cross street will give drivers a final location to turn around.

1. Remove sign and replace with a new sign with the words "at Canal Road" removed.

2. Relocate sign to the final driveway/cross street before Canal Road.

• Replace and relocate sign.
